Contract #: 04-0120F4Cty: SF/ALA Rte: 80 PM: 13.2/13.9File #: 69.28**WELDING INSPECTION REPORT****Resident Engineer:**Siegenthaler, Peter**Address:** 333 Burma Road**City:** Oakland, CA 94607**Report No:** WIR-018112**Date Inspected:** 12-Nov-2010**Project Name:** SAS Superstructure**OSM Arrival Time:** 700**Prime Contractor:** American Bridge/Fluor Enterprises, a JV**OSM Departure Time:** 1900**Contractor:** Zhenhua Port Machinery Company, Ltd (ZPMC), Changxing Island **Location:** Shanghai, China

Bridge No: 34-0006**Component:** OBG/TOWER**Summary of Items Observed:**

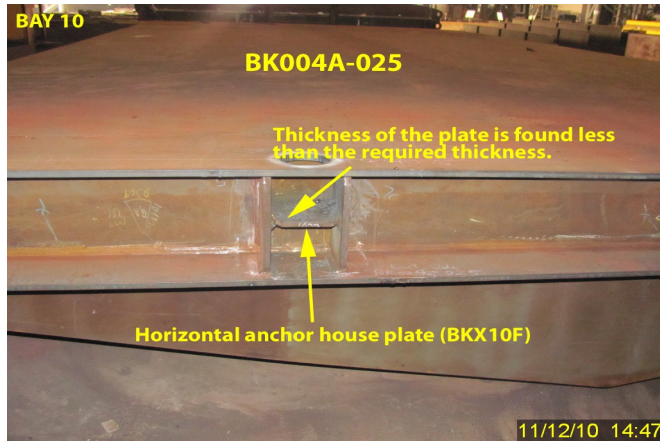
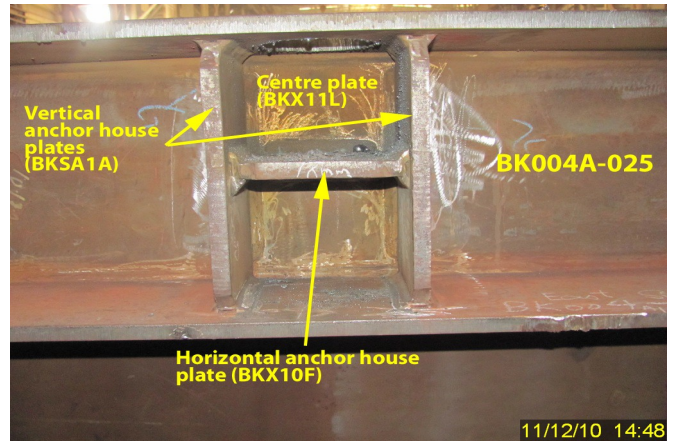
During the Quality Assurance Visual Testing (VT) verification of welds located on vertical and horizontal anchor house plate of OBG bike path BK004A-025, this Quality Assurance (QA) Inspector discovered the following issues:

- The thickness of the horizontal anchor house plate (BKX10F) is found less than required thickness.
- As per shop drawing the required nominal thickness of the horizontal anchor house plate (BKX10F) is 20mm.
- The actual thickness of the BKX10F plate welded was found approximately 16mm.
- The material grade for the 16mm horizontal plate is unknown.
- This plate is located at east side of stringer plate 9C.
- The horizontal anchor house plate (BKX10F) joining the vertical anchor house plates and centre plate (BKX11L).
- The weld numbers are identified as; BK004A4-025-080, 100, 082, 101 and BK004A4-025-083, 102 respectively.
- The member is located in Bay 10.
- Attached photographs provide additional location details.

The Notice of Witness Inspection Number (NWIT) is 07326. These areas have been previously tested and accepted by ZPMC Quality Control (QC) personnel. This issue has an incident report.
